# Three Accidents Involving Lithium Batteries

A brief review of three aircraft accidents where lithium batteries were known to have been on board as cargo

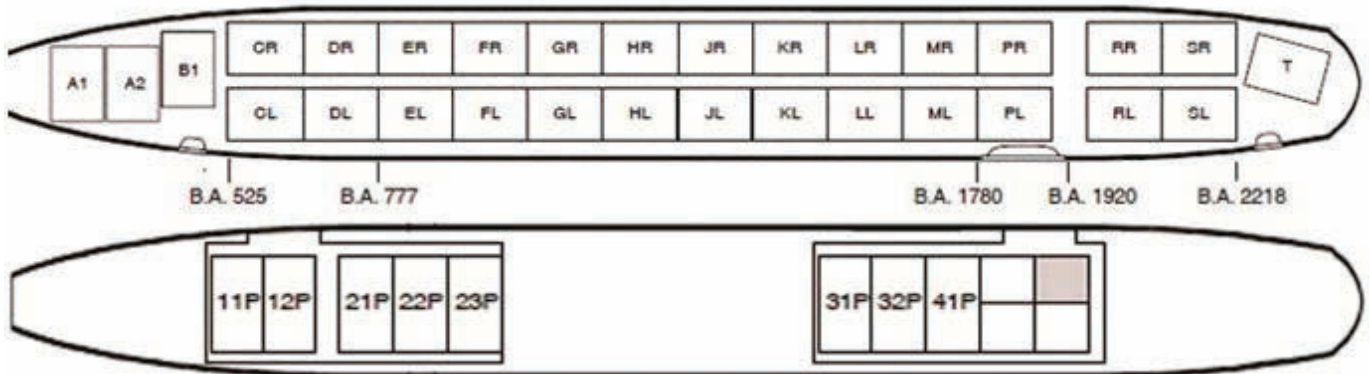
The cargo pallet positions (Graphics: ARAIB):

SR: traces of soot and light melting, severe corrosion

PR: traces of soot and blue dye splatters, cargo net with burnt traces

ML: traces of burning and soot

LR: no traces of fire

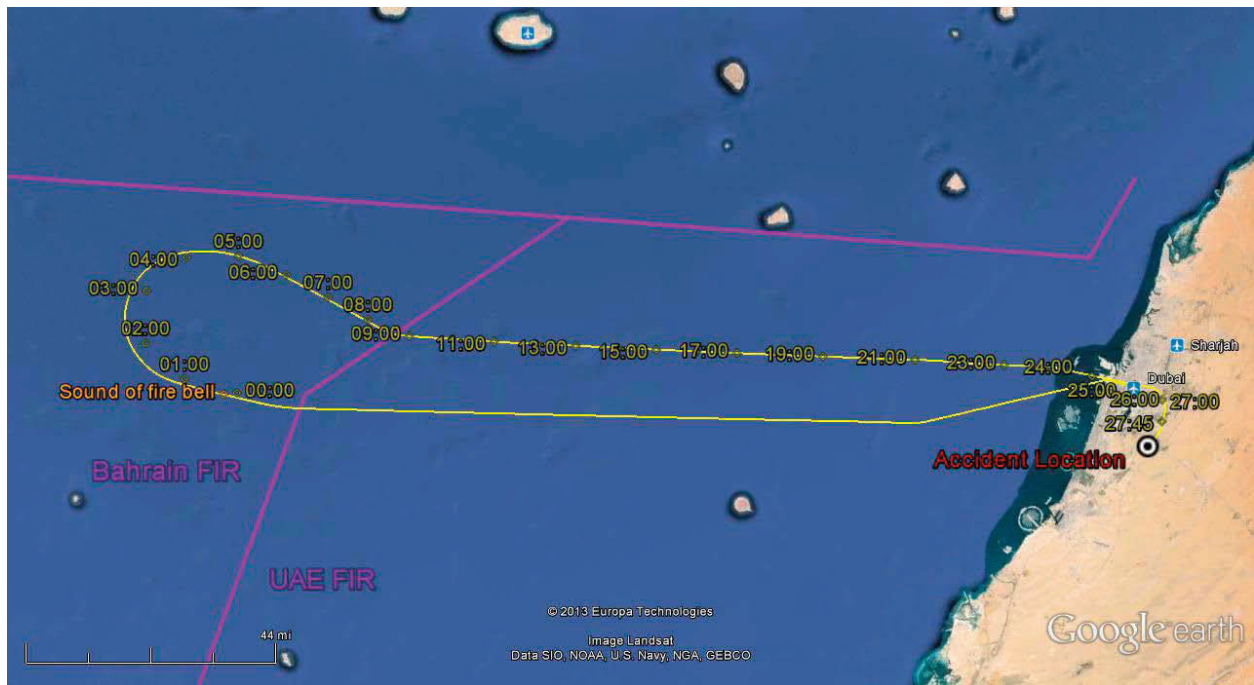
The use of maps and location graphics was used in the final report to simplify the overview of information. To gauge the timeline chronologically from the time of the Fire Master Warning alert, a time from the first fire warning is a sub heading in minutes of elapsed time, is shown in the figure below:

As can be seen, there was a total time of 27: 45 minutes from the fire warning to ditching.
